March 26, 2009

RE: Dam Safety Inspection for Greenbelt Lake Dam (MD Dam No. 8)

Greenbelt Lake Dam

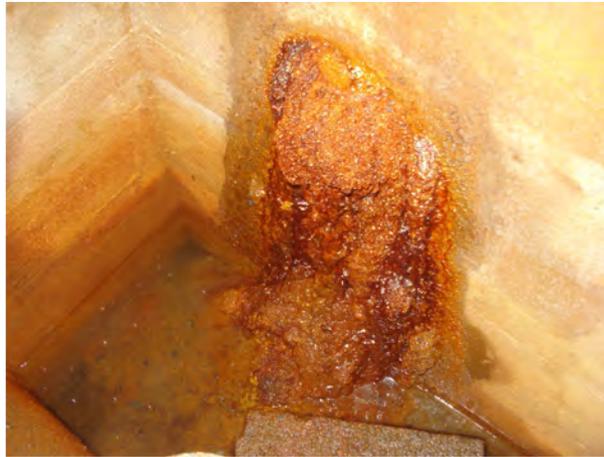
1. There is a leak in the left hand side wall in the lake drain manhole depositing saturated sediment into the manhole (approximately 10" in depth). Pump out the lake drain manhole and remove sediment deposits. Patch the hole in the left hand side wall with hydro-expanding epoxy grout.

Figure 2. Item #1 - Remove sediment from the bottom of the lake drain manhole and patch the leak in the left hand wall of the manhole.

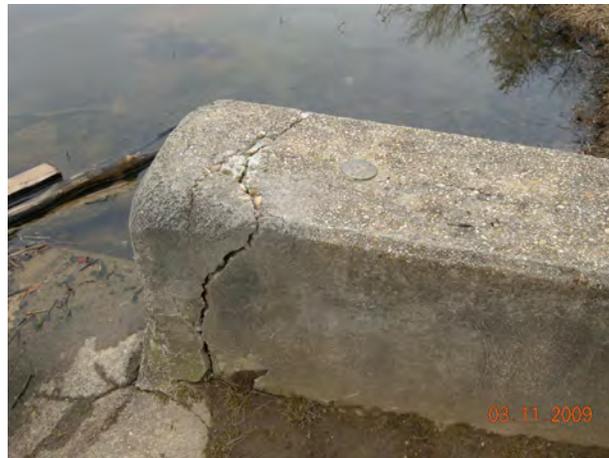
2. Several structural cracks exist in the outlet spillway and wall on the left hand end of the dam. Grout these cracks using hydro-expanding epoxy grout.

Figure 3. – Item #2 – Grout cracks in weir wall adjacent to the spillway using hydro-expanding epoxy grout.

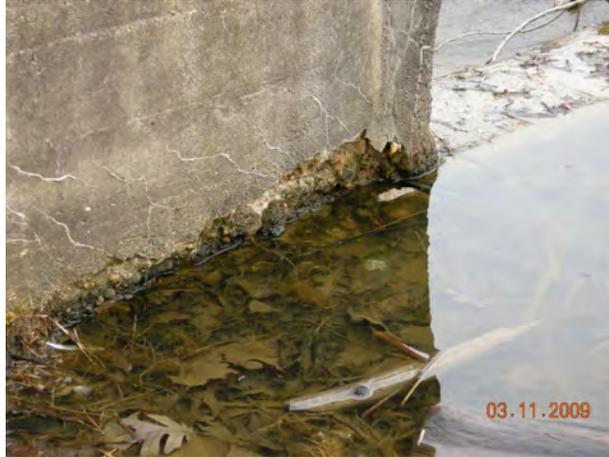
3. There are sections of concrete missing from the base of the wall at the outlet spillway on both the upstream and downstream sides. Patch the wall with concrete to replace the missing sections.

Figure 4. Item #3 – Patch the weir wall adjacent to the spillway with concrete to replace the missing sections.

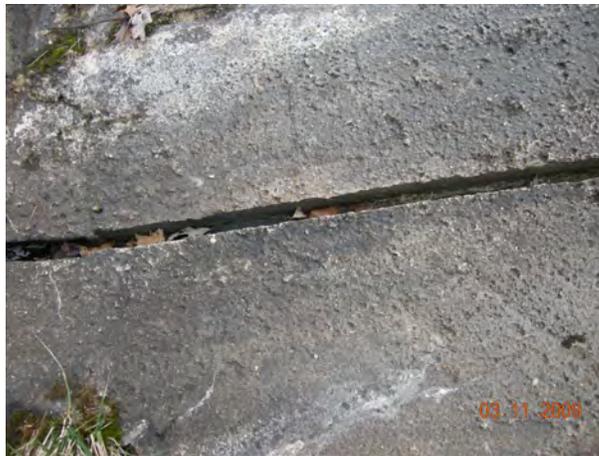
4. There is a construction joint with a large gap in it between two sections of concrete swale in the outlet spillway. Install flexible joint filler in the concrete swale construction joint.

Figure 5. Item #4 – Install flexible joints between the sections of the concrete swale.

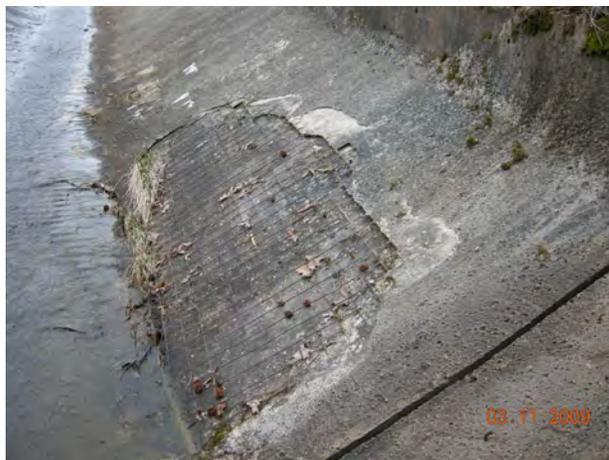
5. In several locations along the concrete swale between the weir wall and the bridge, the Shot-Crete finish has deteriorated exposing the wire mesh reinforcement. Repair the swale by installing new Shot-Crete per the manufacturer's instructions.

Figure 6. Item #5 – Repair the exposed wire mesh by installing new Shot-Crete.

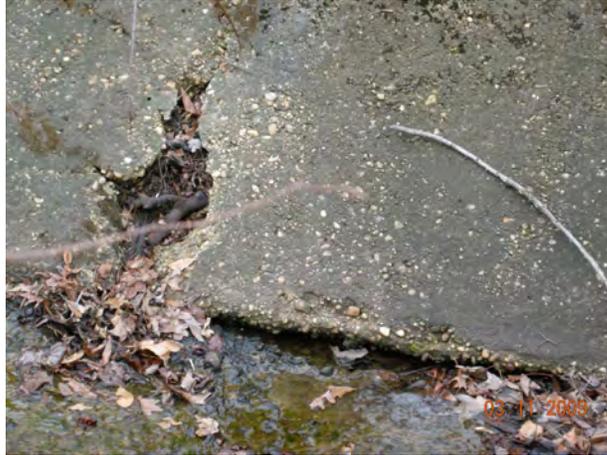
6. At approximately 70 LF downstream of the bridge, on the left side of the concrete swale, there is a severe amount of undercutting of the side of the swale. Repair the undercutting by patching the swale with concrete.

Figure 7. Item #6 – Repair the undercutting at approximately 70 LF downstream from the bridge under the bridge by patching the swale with concrete.

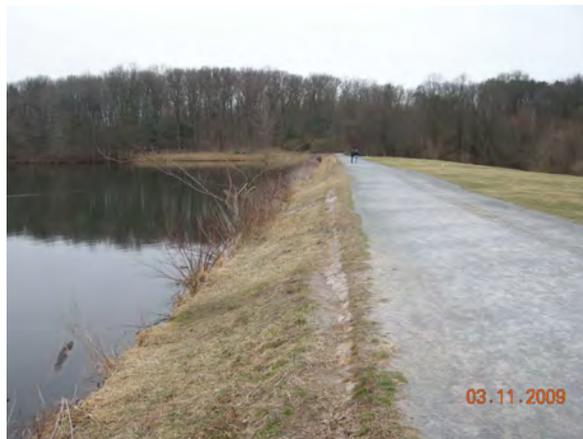
7. The dam is not level from one end to the other. Low points currently exist in the center and far right hand portions of the dam. Level the top of dam (the roadbed) to one constant elevation by adding gravel dust over gravel so possible overtopping flows will not concentrate in one area of the top of dam.

8. There are significant plants growing along the shoreline on the upstream side of the dam. Remove vegetation from along the shoreline on the upstream side of the dam. In general, the tree and plant roots do not need to be excavated unless specified otherwise. The upstream side of the dam should be re-inspected once this item has been addressed.

Figure 8. Item #7 – Level the dam out to one constant elevation.

Item #8 – Remove the vegetation from the along the shoreline on the upstream side of the dam.

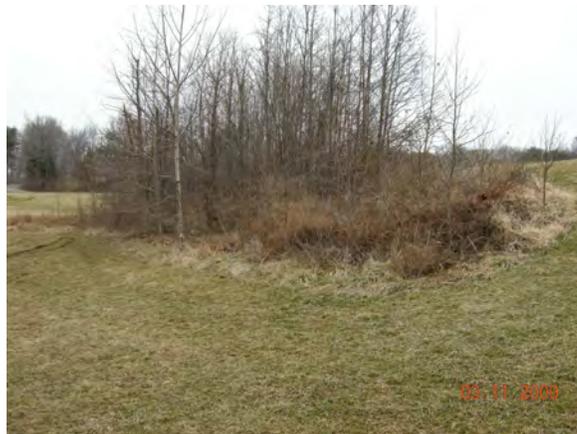
9. There is a stand of trees and vegetation in the center of the downstream slope of the dam. Remove vegetation from downstream face of dam in the center between Observation Well #3 and the W.S.S.C. vault.

11. At least one animal burrow was found in the stand of vegetation located in the center of the downstream slope of the dam. Once the vegetation has been cleared in all areas, repair any animal burrows found by humanely removing any animals from the burrows and filling the burrows with low slump concrete.

Figure 9. Item #9 – Remove the vegetation from the center downstream face of the dam.

Item #11 – Repair animal burrows as necessary.

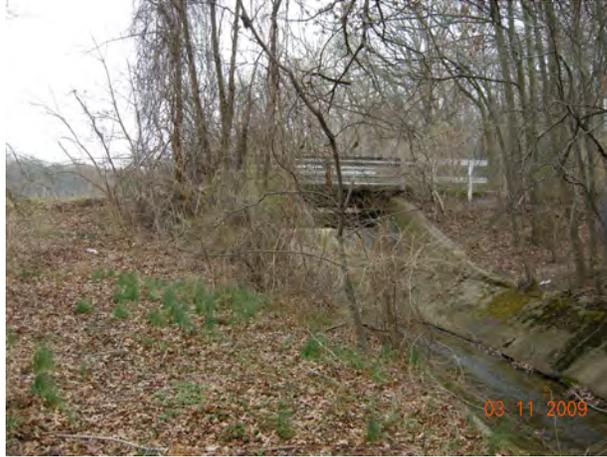
10. There is a stand of trees and vegetation adjacent to the bridge at the left end of the dam as well as growth of small plants, trees, roots, moss and algae in the concrete spillway. Remove vegetation from along the concrete swale at the outlet on the left end of the dam within five feet of the edges of the swale as well as adjacent to bridge on the downstream side of the dam.

Figure 10. Item #10 - Remove the vegetation from along the concrete swale as well as adjacent to the bridge.

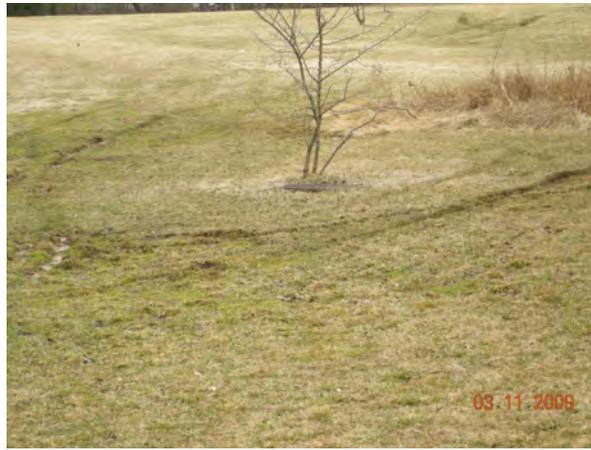
12. Re-grade the downstream "fill area" in the area of seepage to maintain positive drainage towards the concrete swale downstream of the dam.

Figure 11. Item #12 – Re-grade downstream face of dam in “fill area” to maintain positive drainage towards concrete swale.

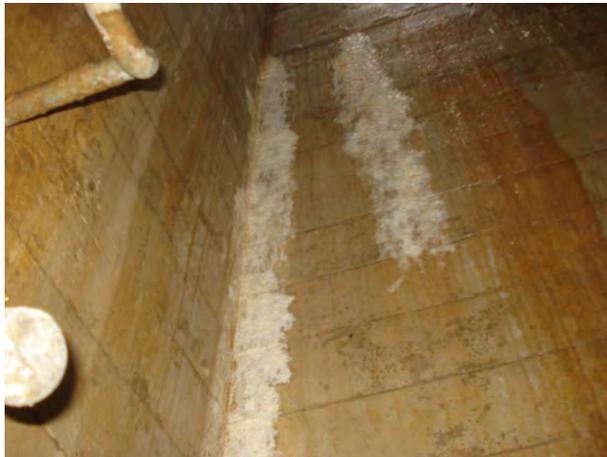
Figure 12. Item #13 – Monitor efflorescence on the walls of the lake drain manhole for cracks.

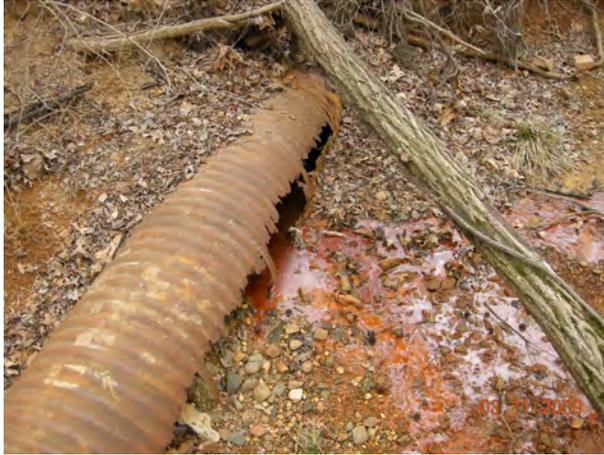
13. Efflorescence exists on the walls of the lake drain manhole. Monitor the efflorescence on the walls of the lake drain manhole for cracks.
14. The downstream end of the 24" C.M.P. /D.I.P. lake drain has completely deteriorated to be non-existent for the last 12 LF. The left toe drain along the lake drain is also non-existent and the right toe drain is filled with sediment. Perform a CCTV inspection of the 24" C.M.P. /D.I.P. lake drain to determine the condition of the remaining pipe. The lake drain should either be slip-lined or replaced depending on the results of the CCTV inspection so it can continue to function.

Figure 13. Item #14 - Perform a CCTV Inspection of the 24" C.M.P. /D.I.P. lake drain.

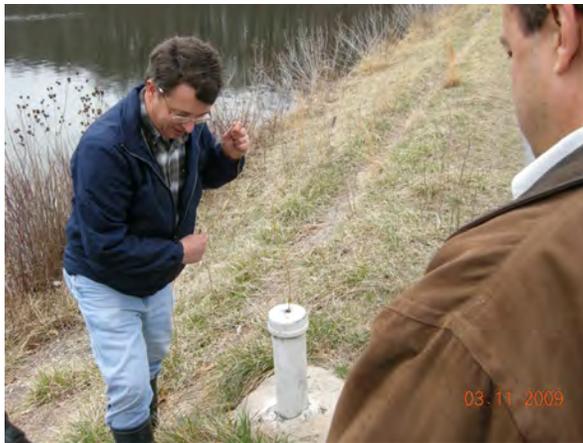
15. Water levels were measured at observation wells #1 (10.3 feet – Elev. 103.1), #2 (15.8 feet – Elev. 95.8), and #3 (6.2 feet – Elev. 102.2). Observation well #4 could not be measure due to structural damage to the well. Wells #1, 2, and 3 should be periodically monitored for changes in water level.

Figure 14. Item #15 – Monitor water levels in observation wells #1, 2, and 3.
